DATE: 2023/05/24

MODEL: SR3/SR1 K8 ENGINE

**GEAR POSITION SENSOR WIRING ROUTING****PRIORITY – MEDIUM (MONITOR)**

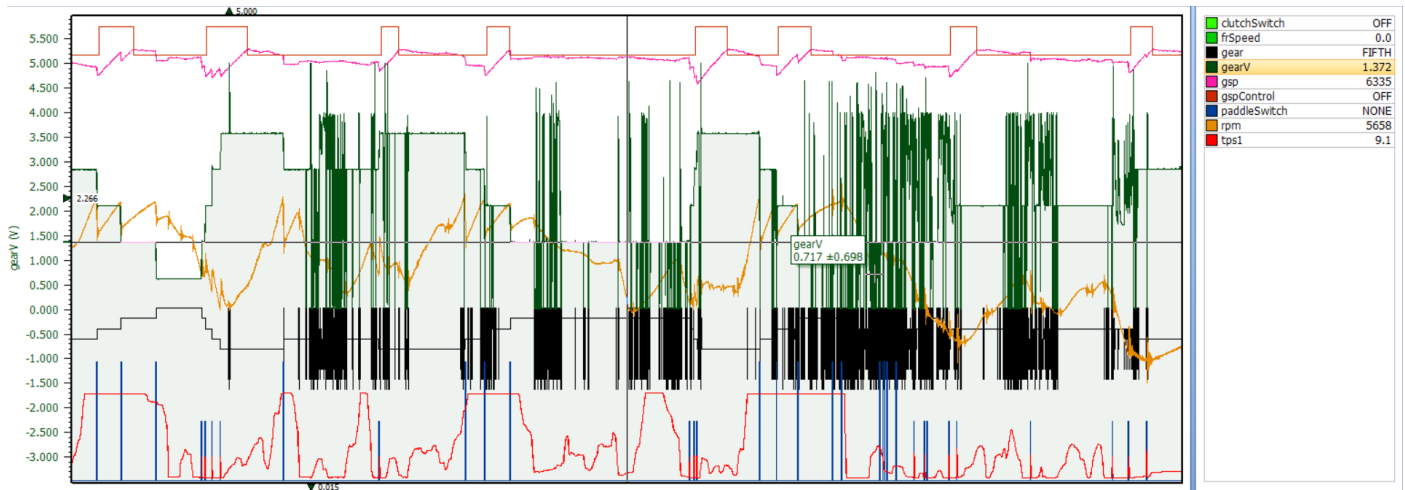
1. Driver will notice gear changes on display while gear change was not requested or shift issues when trying to change gear
2. Gear position and gear voltage trace on Life View will read incorreccted as shown below.

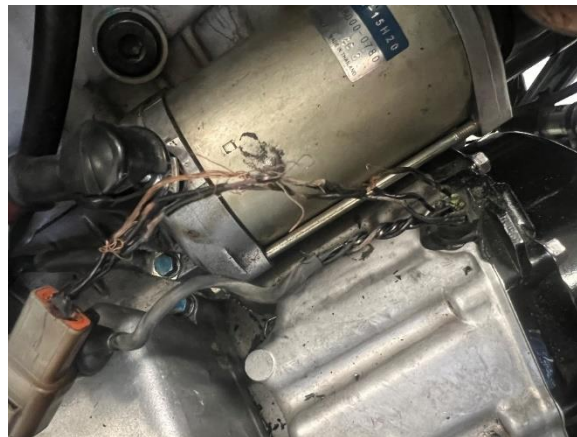
If the wiring has overheated and been damaged the issue will typically present itself in one of three separate ways:

3. Physical inspection of the wiring will uncover heat damage or wiring damage as per the image below. Note that the wiring damage could be internal and not always as obvious.

1. Unplug the sensor and remove the heat sleeve.
2. Check the wiring and plug for any damage.
3. Release the whole length of the Gear position sensor wiring on the harness side.
4. Reapply the heat sleeve making sure the whole length of the wiring is covered. In case the heat sleeve is too short, source a replacement of correct length.
5. Secure heat sleeve on the engine side with cable tie.
