DATE: 2023-06-09

MODEL: SR3/SR10

STEERING COLUMN TUBE**PRIORITY – HIGH (ACTION)**

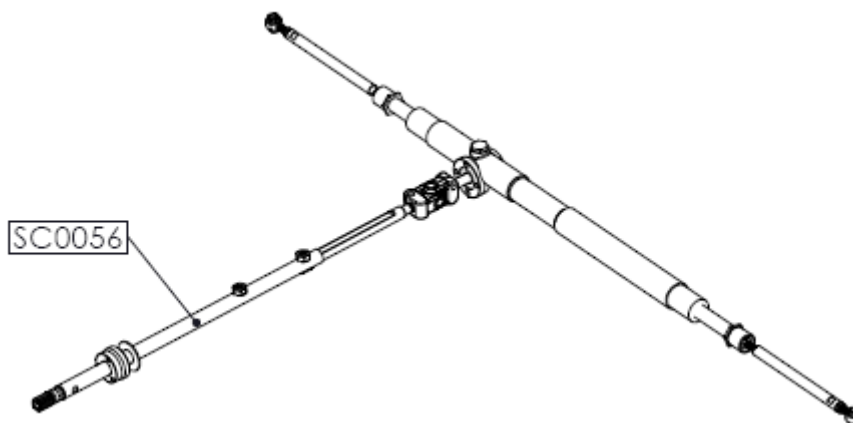
Following 2 unexpected issues Radical has investigated a batch of steering columns fitted to older SR3 and SR8 cars. Small manufacturing tolerance issues were found. Out of an abundance of caution Radical suggests to replace the part. The part has not been used on production cars since 2021.

- 1 – centre the steering position
 - 2 – remove steering wheel, remove lower end of steering column from universal joint
 - 3 – replace steering column and reattach universal joint being sure to check steering is still straight
- Approximate time required 20mins

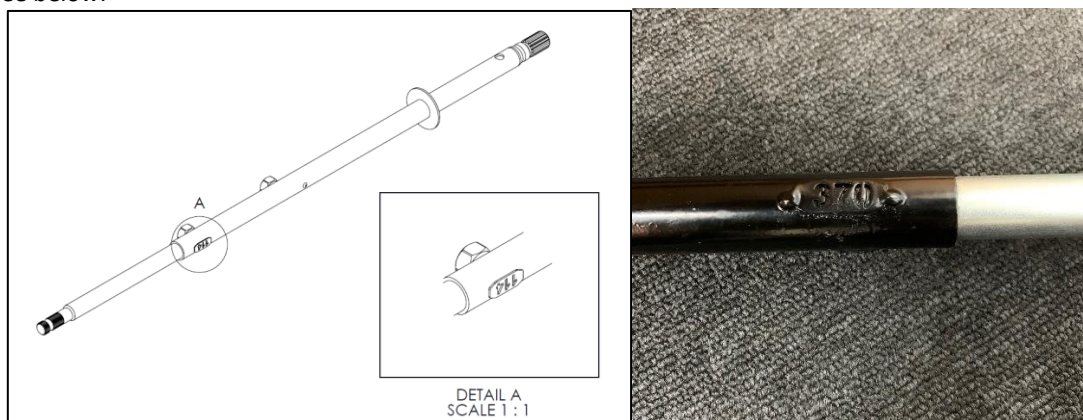
Steering column SC0056. The new parts can be identified by having a physical batch plate now positioned on the lower portion of the shaft, see below:
