MODEL: SR3 XXR

LAMINOVA – HEAT EXCHANGER HR0092

PRIORITY – LOW (INFORMATION)

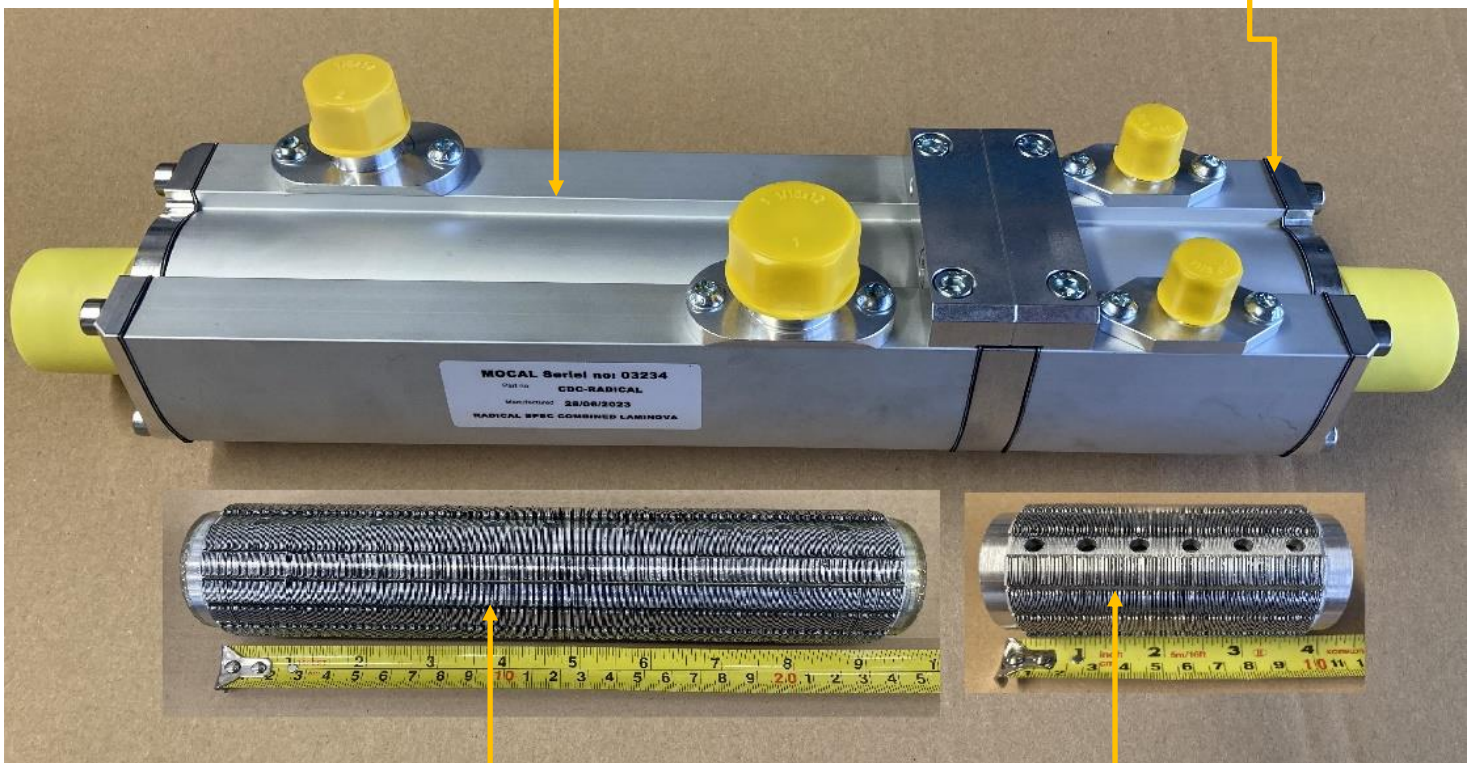
Laminova
HR0092

Rebuild Kit
HR0093

Engine Core Long
HR0095

GDU Core Short
HR0094

In the event of an Engine or GDU Failure where swarf contamination could occur it is important to flush or replace oil lines and replace related Laminova core.

Both of the cores and a rebuild kit containing all gaskets and seals are available from Radical.
