MODEL: SR3 XXR/SR10

PEDAL POSITION SENSOR WATER INGRESS

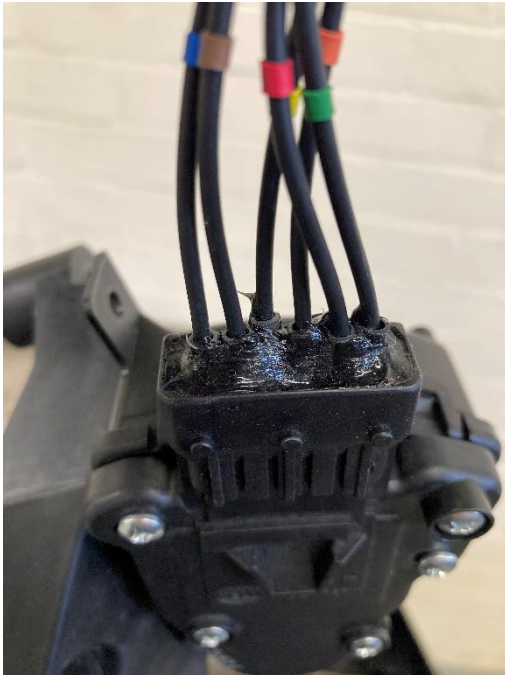
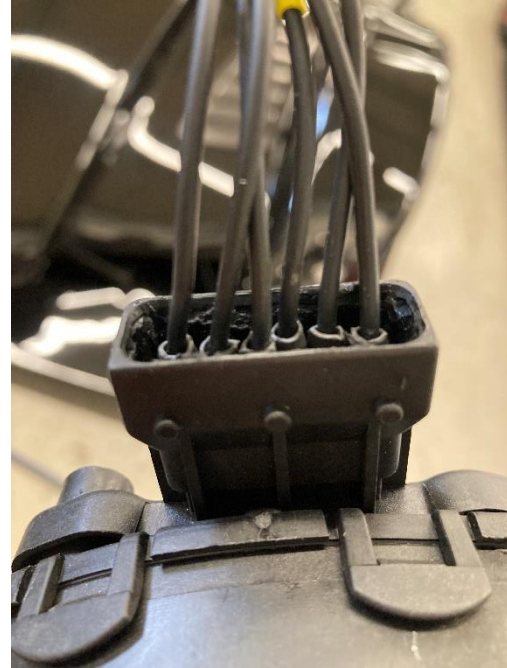
In extreme wet conditions water ingress has been found into the Pedal Position Sensor (ET0072). This can cause electrical issues. To prevent this issue customers are advised to apply the following reliability modification:

1. Remove the PPS from the car.
2. Place the PPS on bench or lock in vice to have good access to the wiring coming out of the sensor.
3. Carefully remove all silicone and trim the excessive heat shrink sticking out of the sensor.
